Re: Hydrogeological Study - Well Certification Report
Proposed Residential Severance
1693 Casey Road
Part of Lot 31, Concession 3 (Thurlow)
City of Belleville
ORE File No. 23-3222

Hydrogeological Study - Well Certification
Proposed Residential Severance
 1693 Casey Road, Belleville
 Part of Lot 31, Concession 3 (Thurlow)
 City of Belleville

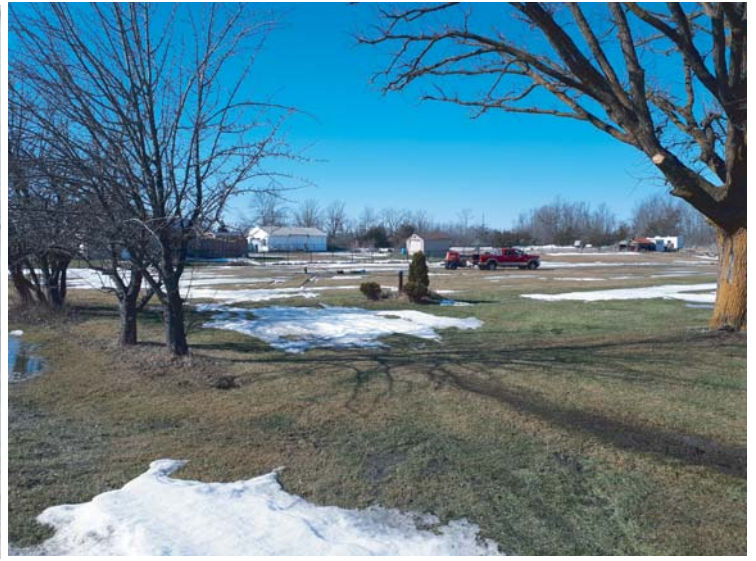
Photo B (above): Looking northwest with W-1 in the foreground

It was noted during the site observations that the nearby monitoring well (W-1) did not have a vermin-proof cap. In addition, some wells in the area have been constructed in well pits,

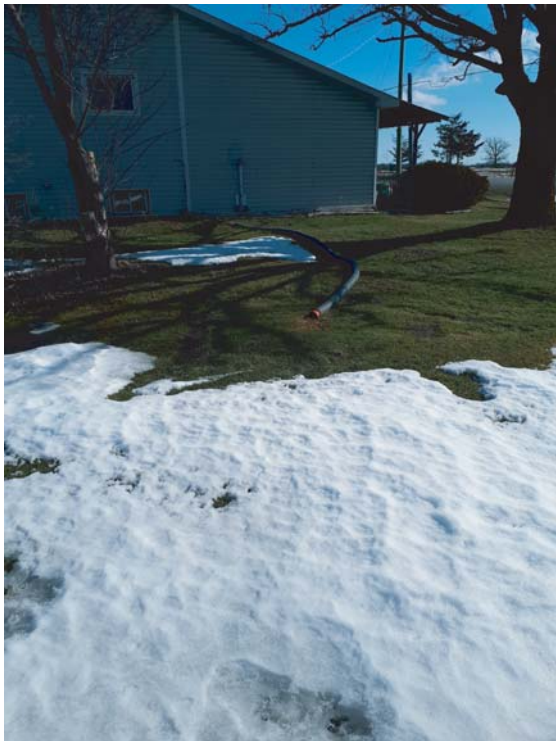
Photo C (above): Sump outfall

During the site inspection, a sump at the residence on the retained lands was observed to be constantly in use (i.e., cycling through many on-off cycles), suggesting a persistent shallow aquifer exists in the study area. Based on the groundwater encountered in the manual (hand

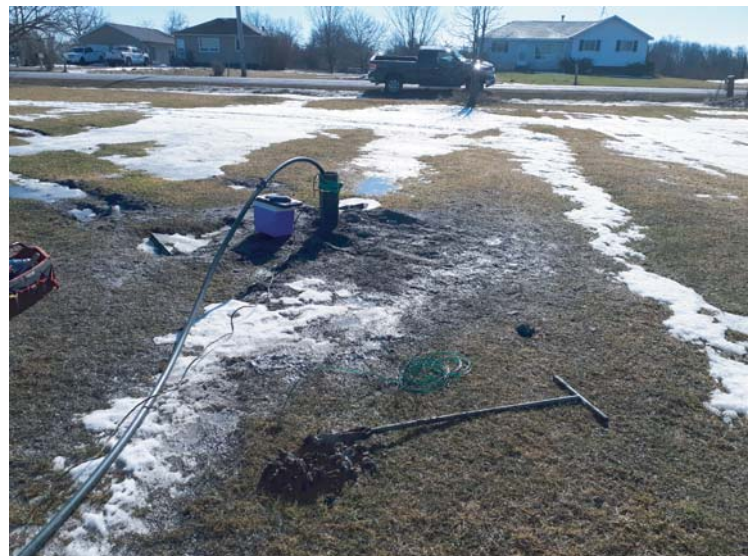
Photo D (above): Looking south at TW23-1, with HA23-1 in the foreground

During the course of the pumping test, a manual auger borehole (“HA23-1”) was advanced within 5 m of TW23-1. Upon completion, the borehole was observed to fill with shallow groundwater and was subsequently outfitted with a datalogger to monitor whether there was any direct hydraulic connection between the shallow groundwater and the supply aquifer.

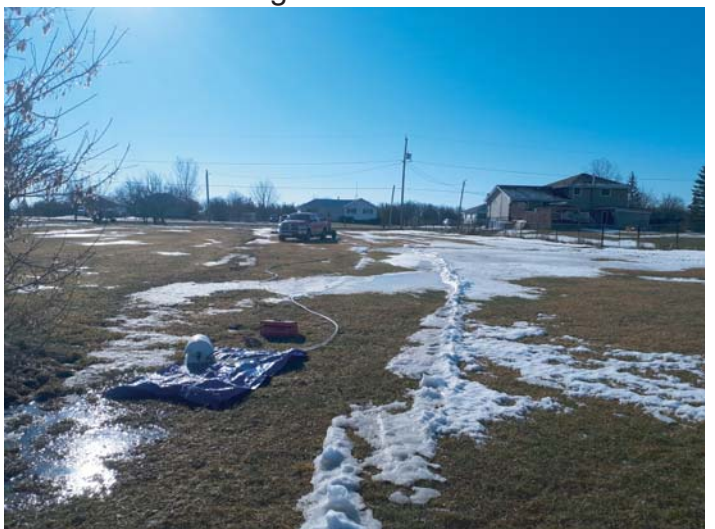
Photo E (right): Looking south at pumping test discharge location

Discharge water, from the pumping test, was directed to a tarp to prevent erosion and sedimentation 52 m north of the well location. The discharge waters followed a natural overland drainage swale that directed the water towards the wetland to the north.

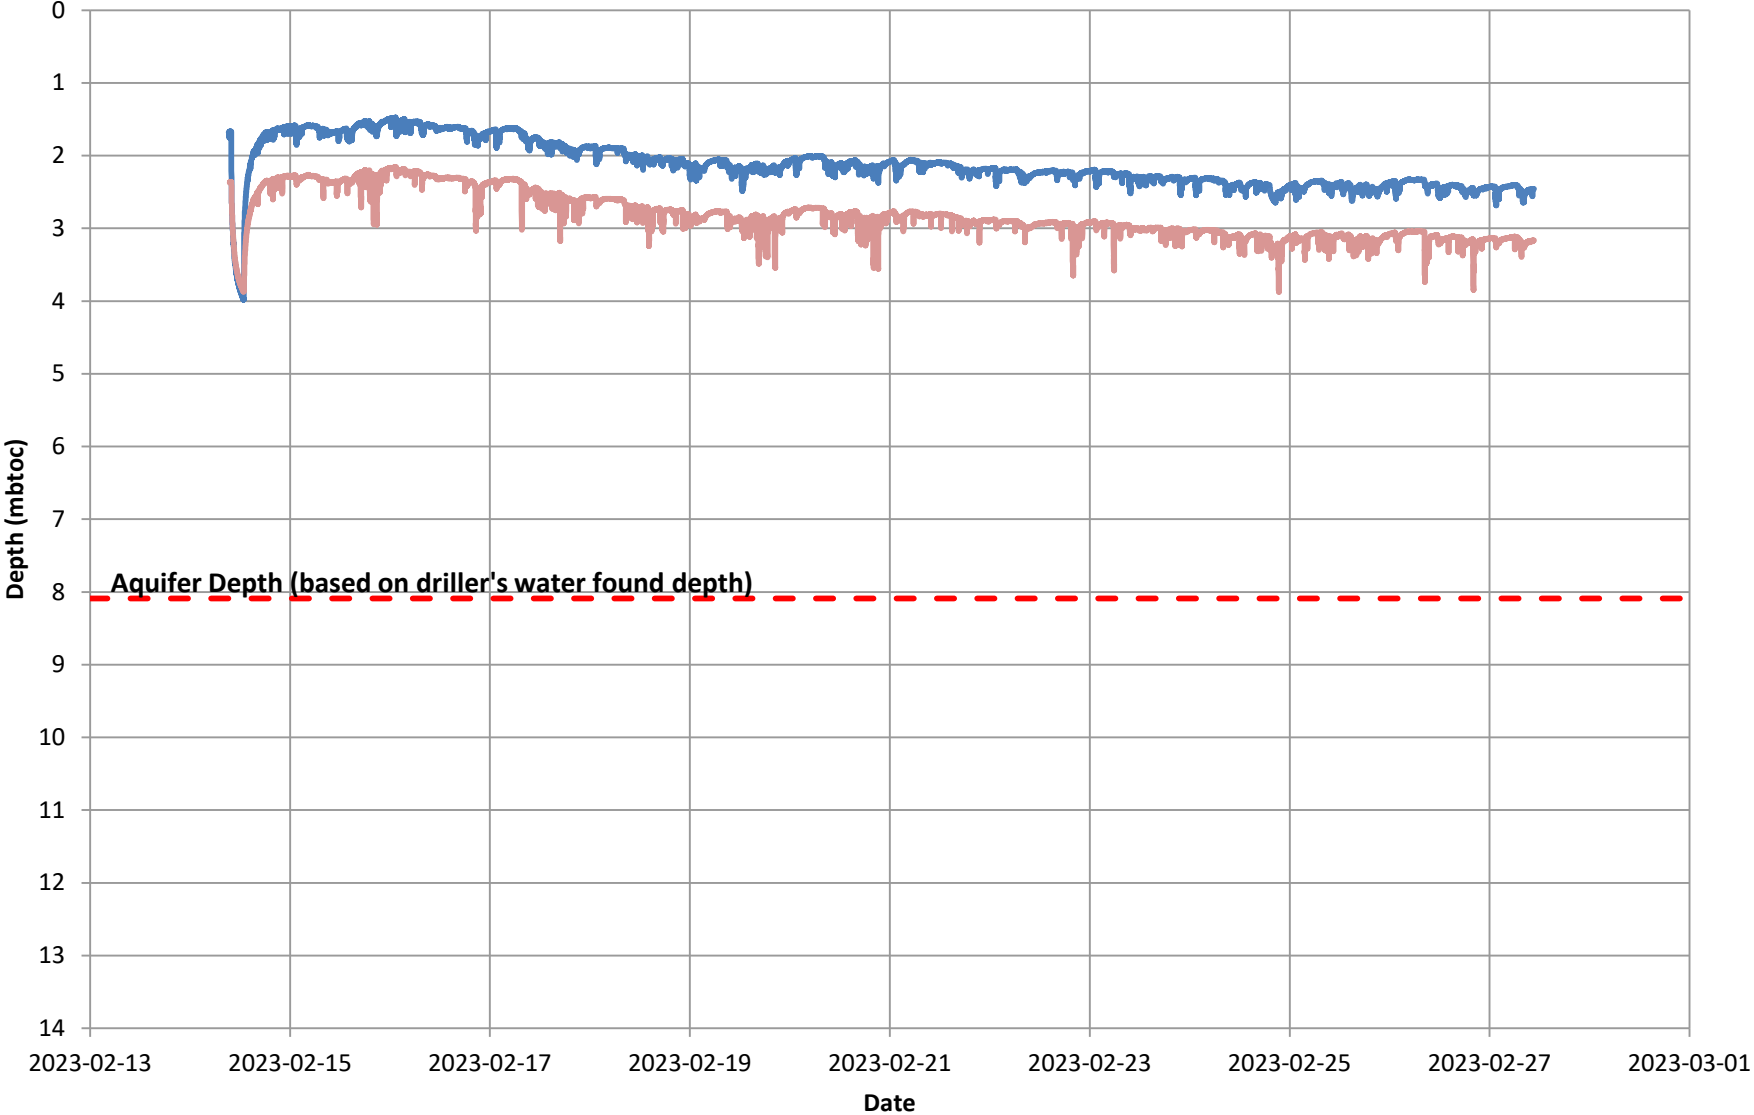
1693 Casey Road Long-Term Hydrograph

— TW23-1 — W-1

It is expected that the precipitation event (i.e., >26 mm of rain as recorded by Environment Canada - Belleville) and associated snow melt on February 9, 2023 may have contributed to the elevated water levels observed at the site between February 14th and February 16th. Following this period in the monitoring data, the water levels appear to decline and may be showing signs of stabilizing between February 25th and February 27th.
